Manhole Inspection Summary

Manhole # S49K__004MH

Insp Date: **2/6/09 1:07 PM**

Location Address: **2342 FLEET ST** Cross Street: **S MONTFORD AV**

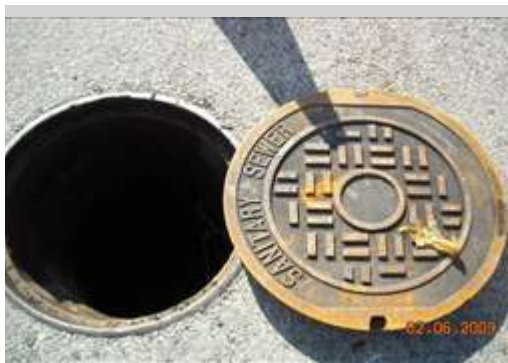
MISC.

REPLACED BROKEN COVER WITH
WATER TIGHT LID

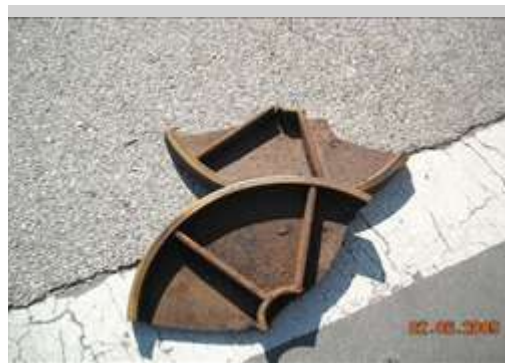
MISC.

Comments **BROKE AND REPLACED 24 INCH COVER (see photos)**

BROKE COVER TO GAIN ACCESS

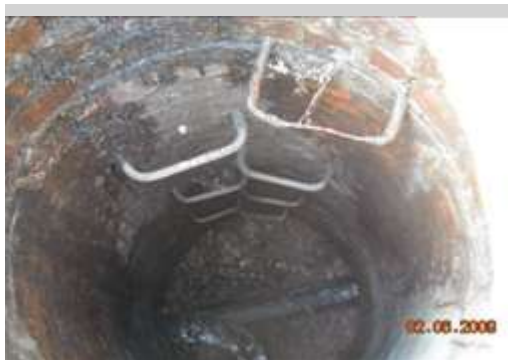
Defect 1

Steps Count: **7** Missing: **0** ☒ **Corroded**

CORRODED STEPS

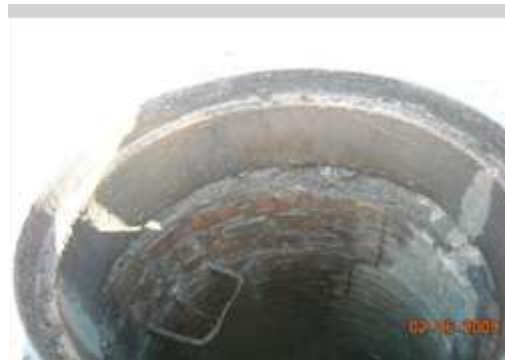
Defect 3

Frame Offset: **1** (in.) Condition: ☐ Sound ☐ Cracked ☒ **Leaks**

frame leaks

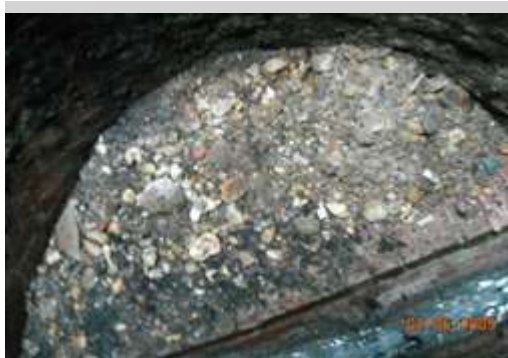
Defect 4

Condition: ☐ Sound ☐ Cracked ☐ Root Intrusion ☐ Deteriorated ☐ Leaks ☒ **Debris**

DEBRIS ON BENCH

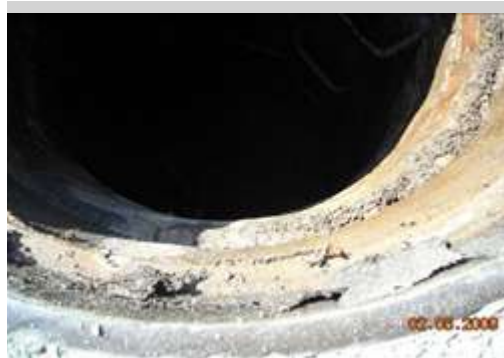
Defect 2

FRAME OFFSET

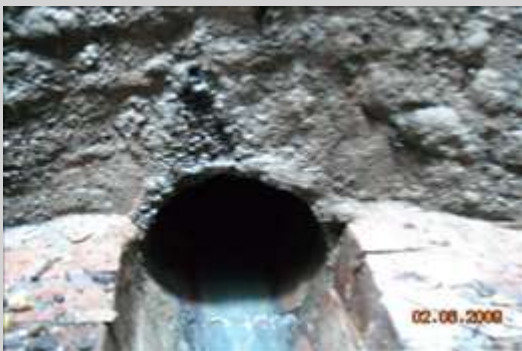
6 O'Clock Inflow

Pipe Height: **8.4** (in.) Rod and Bar (Angled)
Pipe Material: **Clay** ☐ Pipe Lined
Invert Depth: **10.80** (ft.) Flow Characteristics: **Slow**
Deposits: ☒ None ☐ Mud ☐ Sludge ☐ Debris ☐ Grease
Silt Depth: **0** (in.) Deposits Extent:
Infiltration: **Weeper** Pipe Seal Cond: **Sound**
